EVALUATION OF CONSTRUCTION TECHNIQUES IN THE ESTABLISHMENT OF COASTAL SAND DUNES

**FINAL REPORT
MARCH 2008**

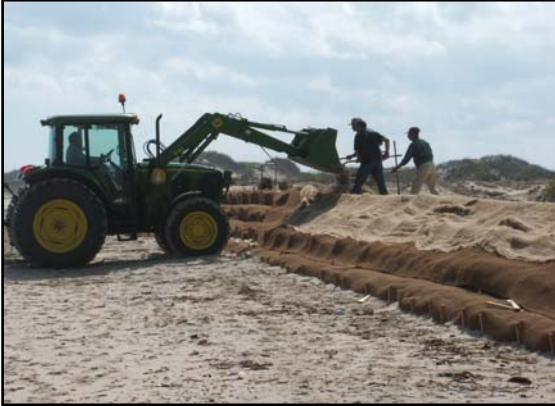
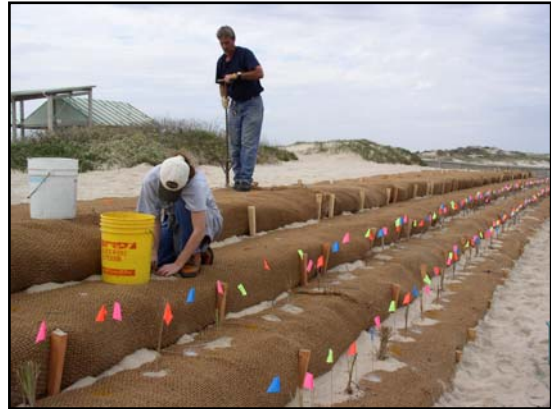
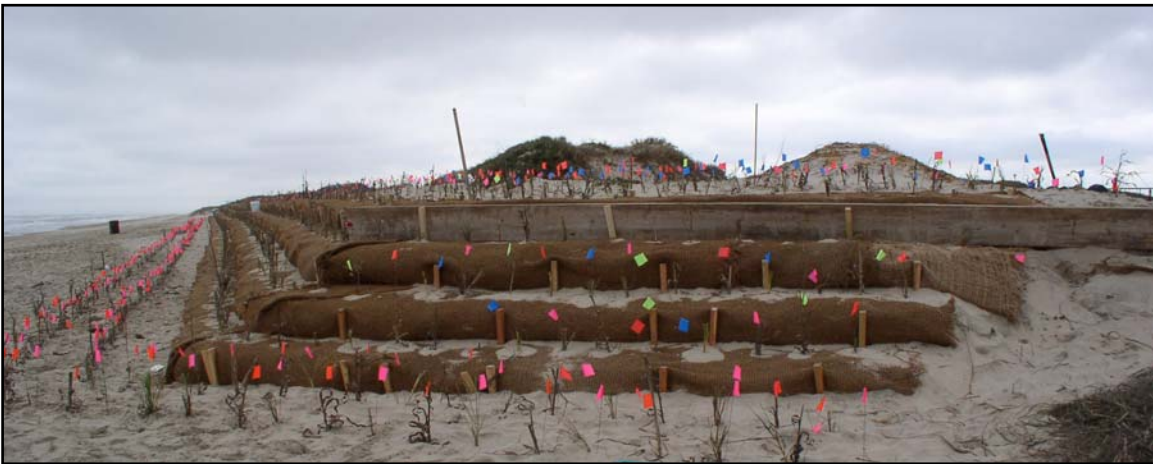
First Dune Construction - January 2005

In January 2005, the PMC coordinated with The Nature Conservancy (TNC), the South Padre Island Parks Department (SPIPD), and the U.S. Fish and Wildlife Service to form 300 feet of encapsulated soil in order to construct and vegetate a 4 foot high by 40 foot wide sand dune. The dune was constructed by having a front-end loader and operator provided by SPIPD level out a 300 foot-long area. The PMC along with TNC volunteers placed down 300 feet of biodegradable coir fabric. The fabric was staked down and then folded over batter boards. The batter boards form a temporary framing for the sand used to make the lift layers. Sand was brought in by SPIPD and placed on the fabric to a height of 12 inches and then watered and compacted. Then the extra fabric was pulled back over the sand and secured with 24 inch stakes.

Once a lift was completed, the batter boards were removed and used for the next lift. The outer edge of the next lift was set back 2 feet from the previous lift. A total of 4 lifts were constructed. The distribution of the fabric lift was 3 feet on the bottom, 12 inches on the edge and 3 feet on the top. Additional sand was also needed to form the 3:1 dune backslope. The dune was planted with PMC supplied plant material. The beach front was planted with 2 rows with alternating spacing of containerized bitter panicum and sea oats, as well as with bareroot bitter panicum and sea oats. Plants were spaced 1 foot apart. Alternating species were planted every foot into the exposed shelf of the soil lifts. The 20 foot area on top of all the soil lifts was planted as 9 staggered rows with the rows 2 feet apart. An alternating sequence of the 2 grass species was planted every 2 feet. The 3:1 back slope was planted as 4 staggered rows with the rows 2 feet apart. An alternating sequence of the 2 species was used at a 2 foot spacing. The PMC conducted an as-built survey once the dune had been constructed.

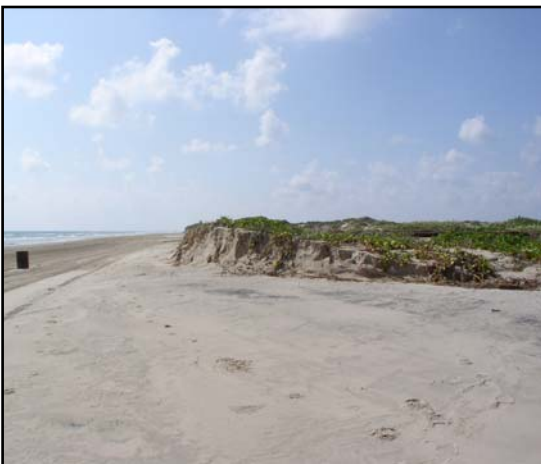
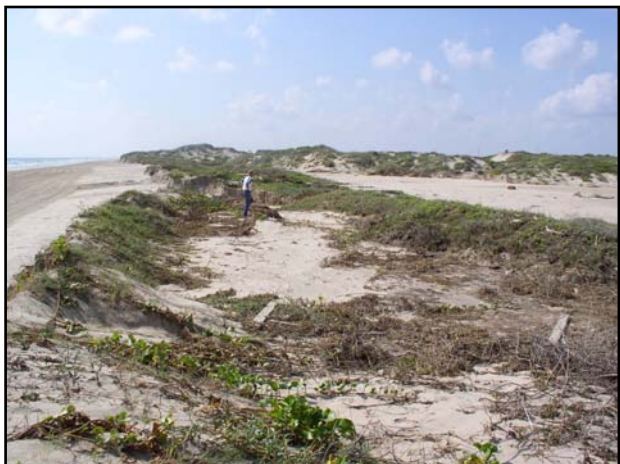
First Dune After Rita – September 2005

Hurricanes Emily and Rita in 2005 destroyed most of this dune. The fortunate aspect of the destruction of the dune is that it allowed the PMC to evaluate some new construction methods. The PMC reconstructed a dune 220 feet long on the same site in 2006. The new dune included the use of coconut fiber bales, coconut fiber blocks with matting, and also “concertainers,” metal cages filled with sand and covered with coconut fiber. The dune was also used to compare the success of plant material from a population near Corpus Christi and from a population near the dune. Watering and hydrogel techniques were evaluated for their effect on plant survival.

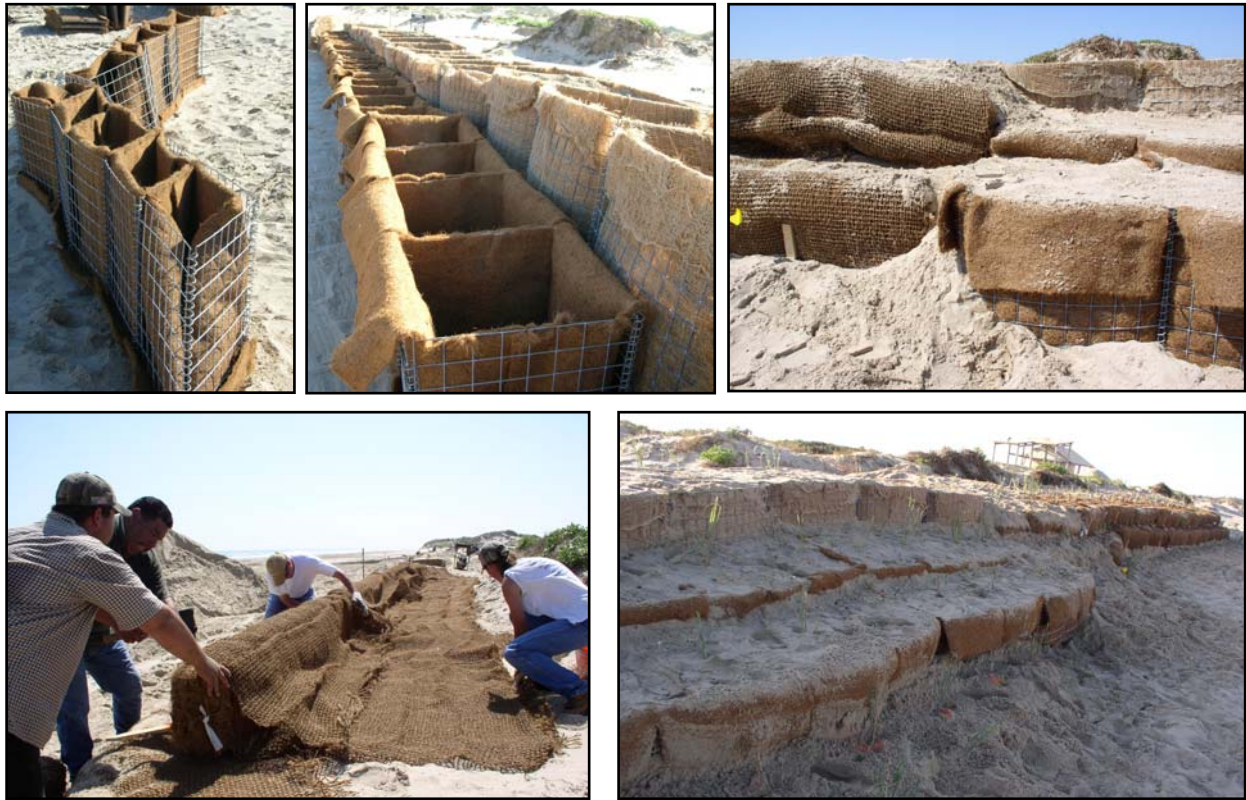
Second Dune Construction – March 2006

The dune was constructed, planted, and watered in March 2006. PVC tubing and hydrogel treatments were installed in April. A second watering was applied in May. The PMC conducted an as-built survey following the dune construction on March 13, 2006 (Table I). Plant evaluations occurred in May and November of 2006 (Table II). A final topographic and plant evaluation occurred on February 15, 2008.

Over the course of 23 months, there was an average accumulation of 1.6 feet of sand at all locations on the constructed dune (Table I). There was a loss of sand at only one location. At station S5 - 0+00, which was at the top of the dune, there was a recorded loss of 0.15 feet. The greatest accumulation occurred at S5 – 0+25 with a recorded increase of 2.38 feet of sand. All of the dune construction methods worked very well. We were especially pleased with the speed and ease in using the “concertainers.”
